U.S. Department of Energy
Office of Inspector General
Office of Audits and Inspections

Inquiry into the Security Breach at
the National Nuclear Security
Administration's Y-12 National
Security Complex

DOE/IG-0868

August 2012

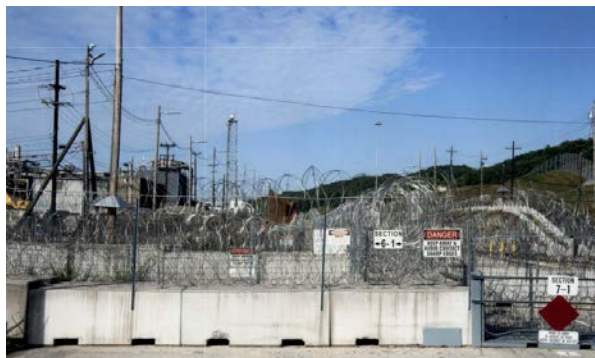
Photograph 1-Delay Barriers

Contractor officials expressed concern that constrained Federal funding had negatively impacted security controls at Y-12. For example, NNSA made a decision to eliminate some security features surrounding the HEUMF prior to completion of construction in 2008. Plans to install an additional delaying barrier were abandoned during construction. One official told us that the decision to exclude the delaying/prevention barrier was appropriate because of the security features of the HEUMF. Other officials told us that the feature, in place in the Protected Areas at other sites, was omitted because of budget considerations. The installation of barriers similar to those used in other portions of the Protected Area (as shown in photograph 1) would have complicated, delayed or perhaps even prevented the intrusion by the trespassers.
